VCI 2007, Vienna,
February 18-24, 2007

Design and Production of the LHCb Silicon Tracker

Olaf Steinkamp

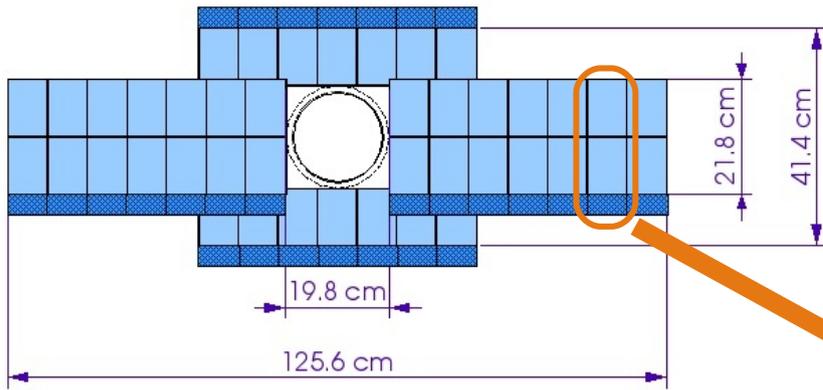
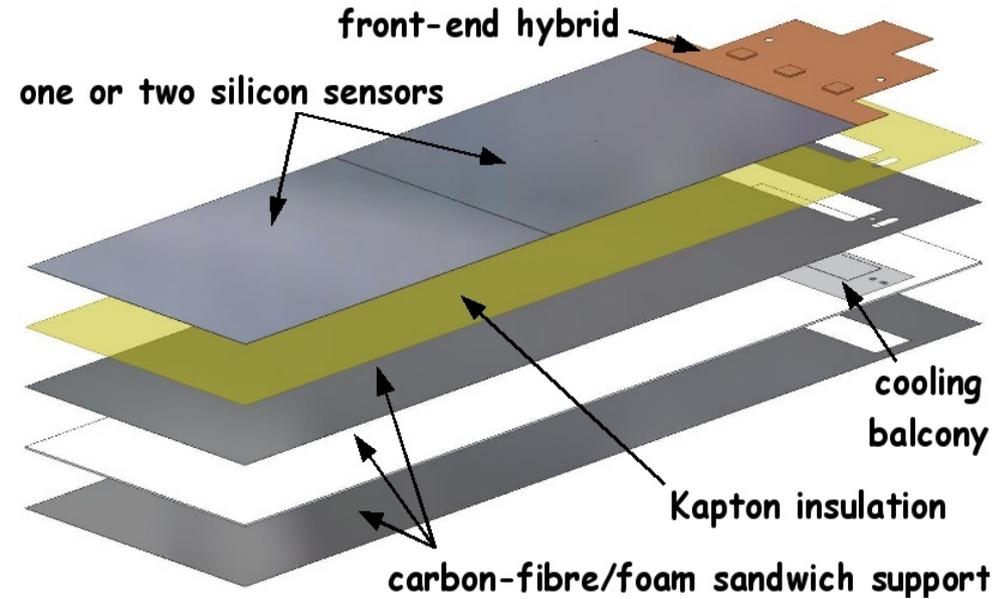
Inner Tracker

Three stations with four layers each:

- 1-sensor ladders above/below beam pipe
- 2-sensor ladders left/right of beam pipe

- material budget
 - sensors as thin as possible
 - 320 μm for 1-sensor ladders
 - 410 μm for 2-sensor ladders
 - supports / cooling etc.
- cost (number of r/o channels)
 - large pitch (197 μm)

**$\sim 4.2 \text{ m}^2$, 504 silicon sensors,
336 modules, 130k readout strips**

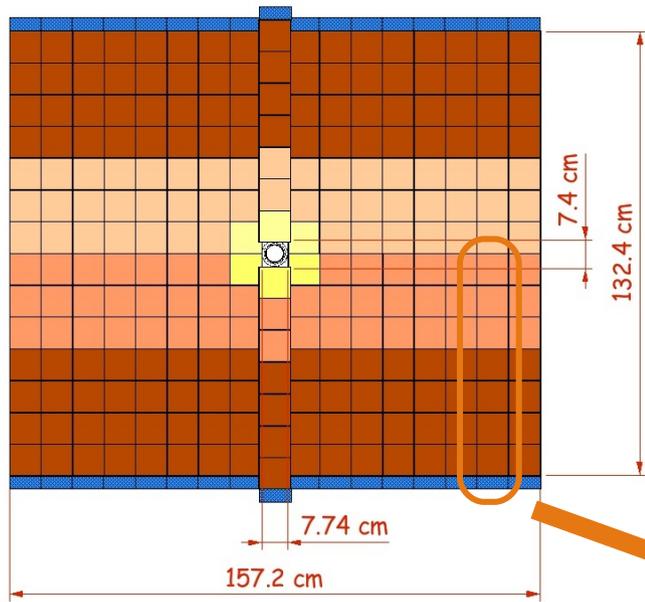
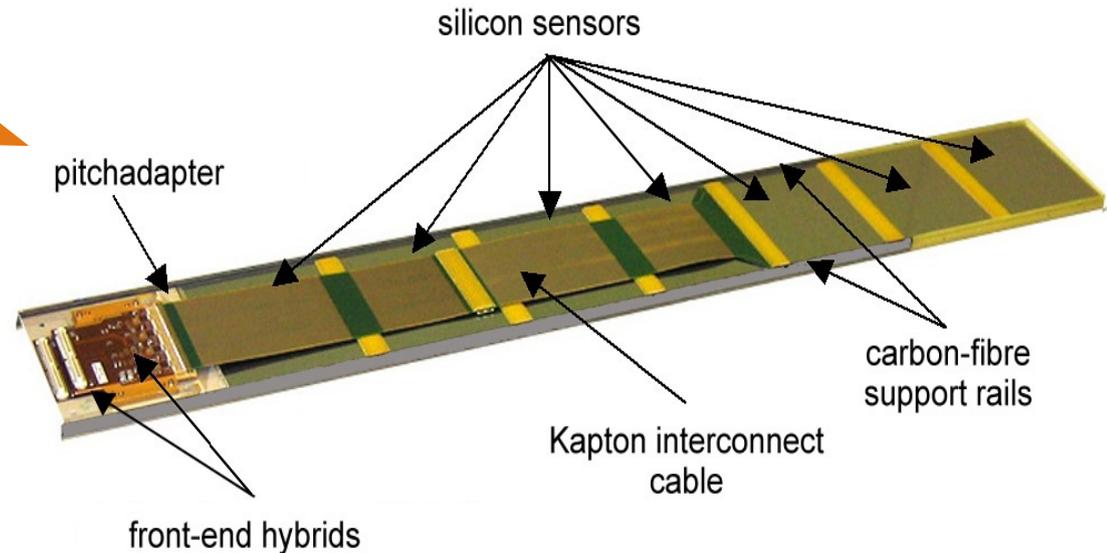
Trigger Tracker

One station with four detection layers:

- 7-sensor long modules
- up to 4-sensor long readout sectors
- all r/o hybrids at one end of the module
- "inner" r/o sectors: Kapton interconnects

- material budget:
 - r/o hybrids outside acceptance
- cost (number of r/o channels)
 - large pitch (183 μm)
 - long strips (up to 37 cm)
- S/N for very long readout strips

**~ 8.2 m², 896 silicon sensors,
280 r/o sectors, 143k r/o strips**

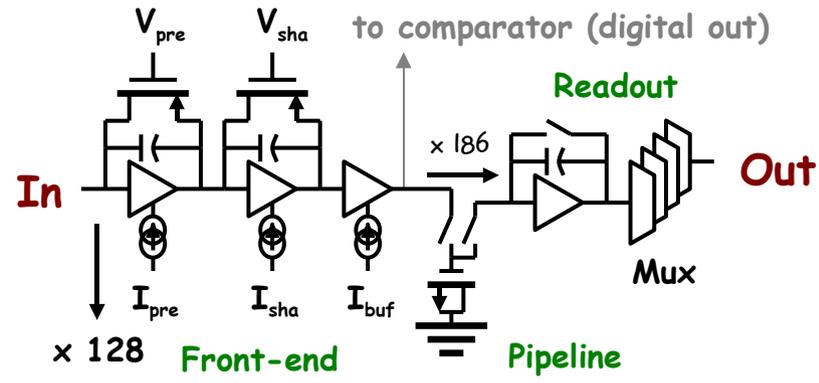
"Beetle" front-end readout chip:

- radiation-hard design in 0.25 μm CMOS
- analog pipeline, multiplexed analog readout
- adjustable shaping time of ~ 25 ns

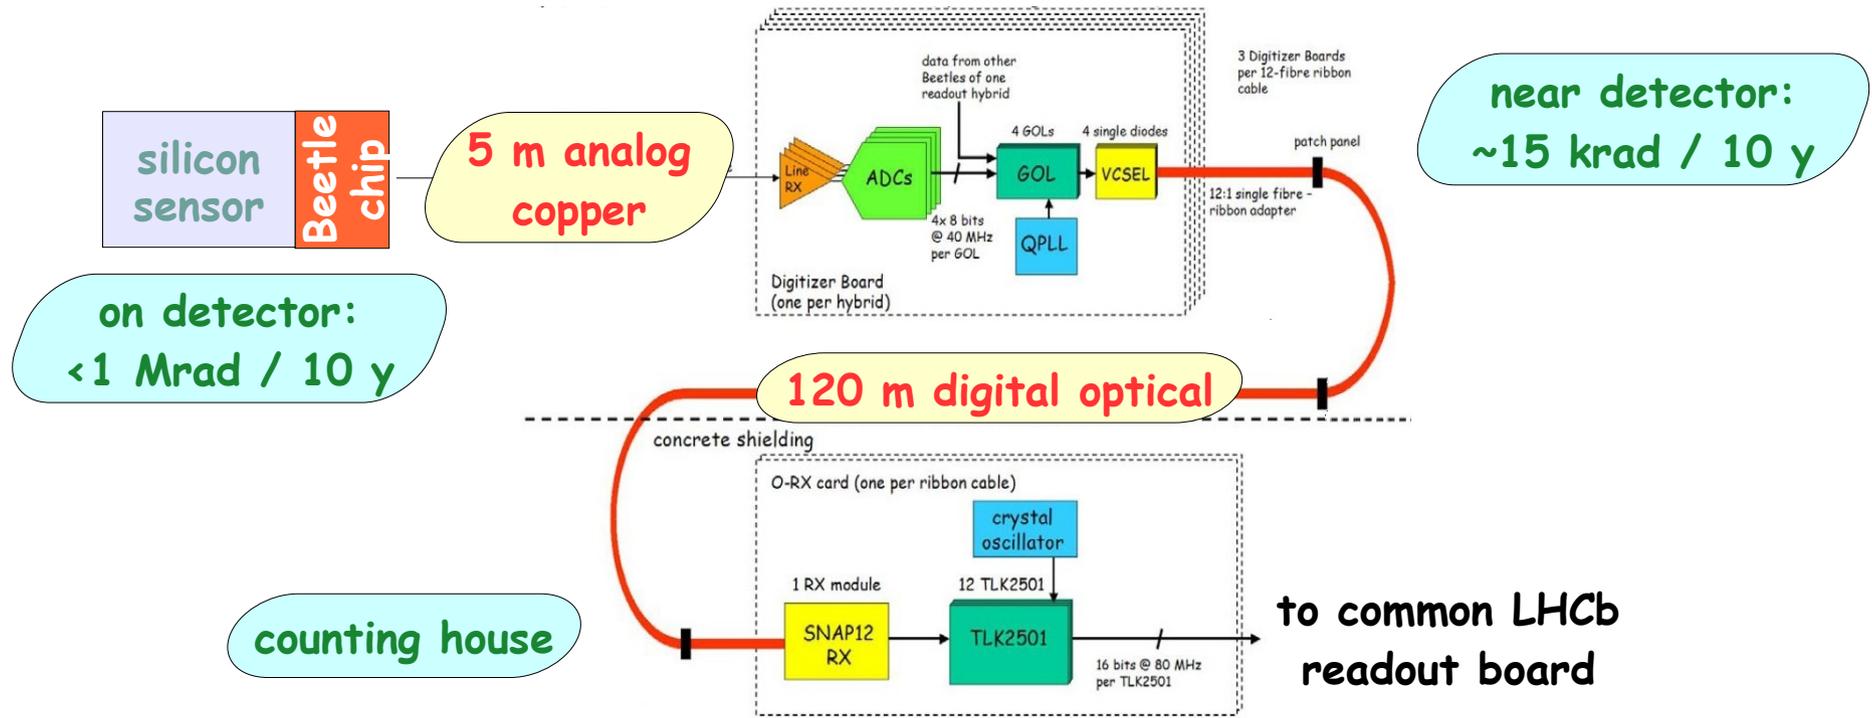
Digital optical readout link:

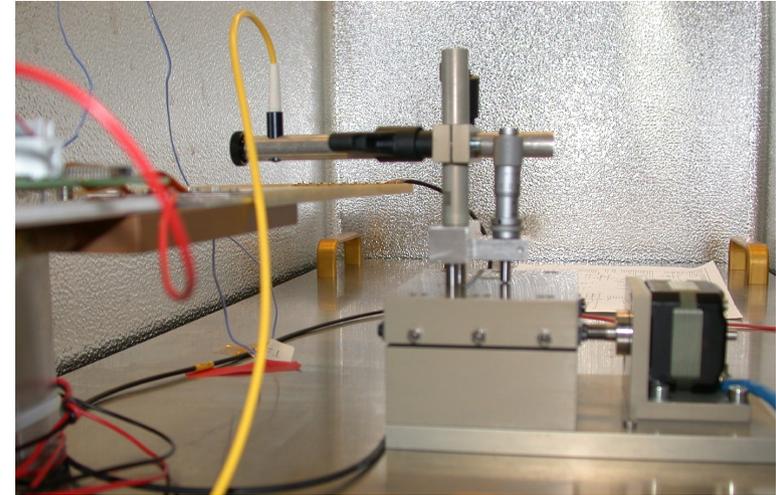
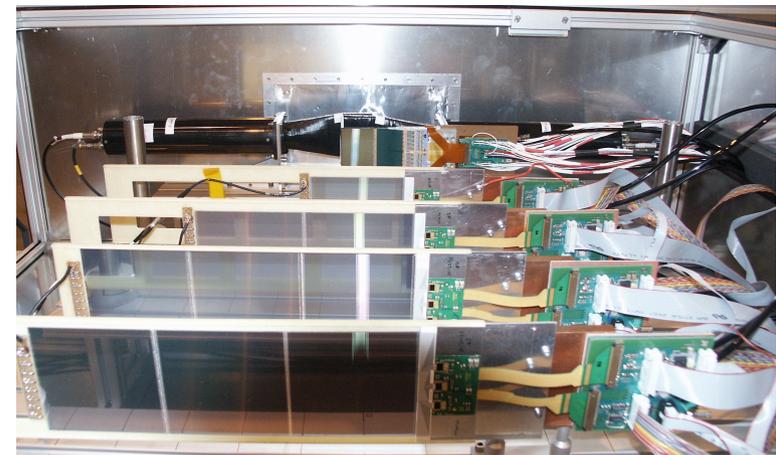
Various prototypes tested:

- different sensor thicknesses, strip lengths, strip geometries (pitch, implant width)
- with and without Kapton interconnects
- all read out with Beetle front-end chip
- test beams and IR-laser test stand

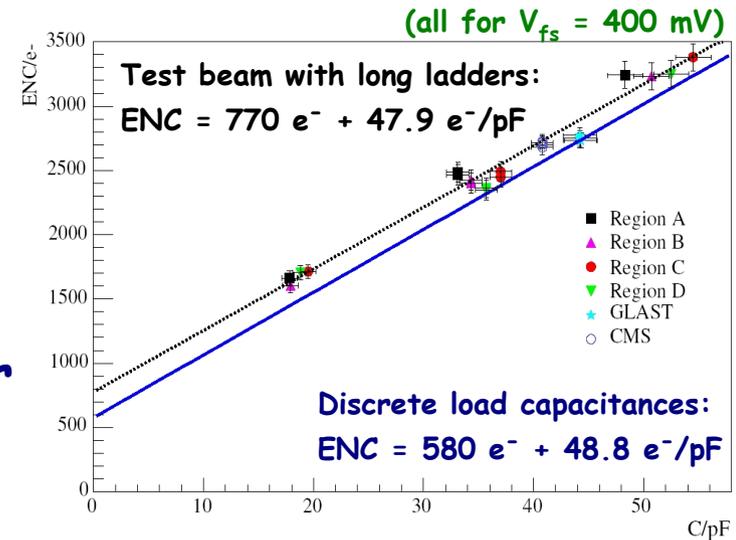
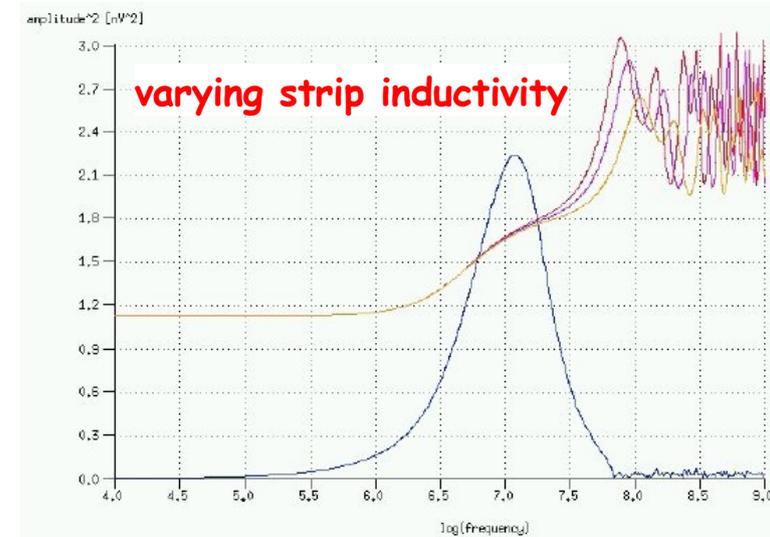
Noise proportional to detector capacitance:

- observed no significant noise contribution from strip resistance (up to 33 cm strip length)
- confirmed by SPICE simulation of r/o strips (as LCR network) and Beetle front-end amplifier
- careful: convolution of detector noise spectrum with frequency response function of amplifier

Also: no deterioration of signal integrity due to the Kapton interconnects

- behave just as an additional capacitive load
- again, confirmed in the SPICE simulation

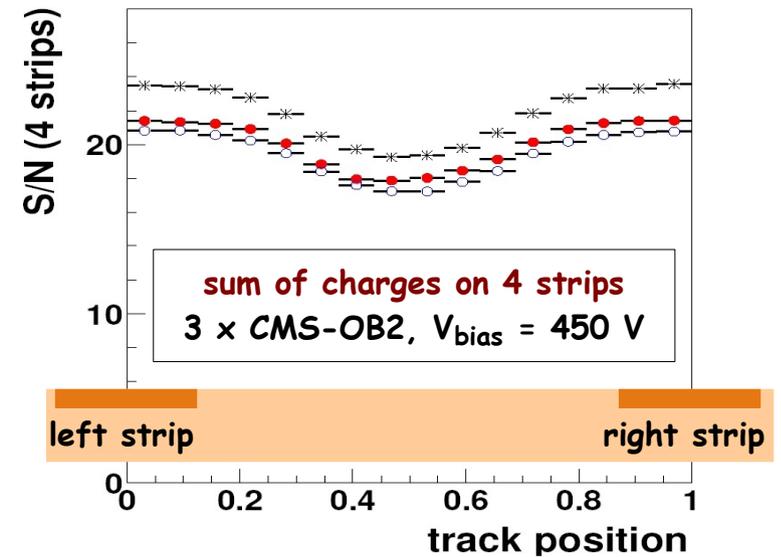
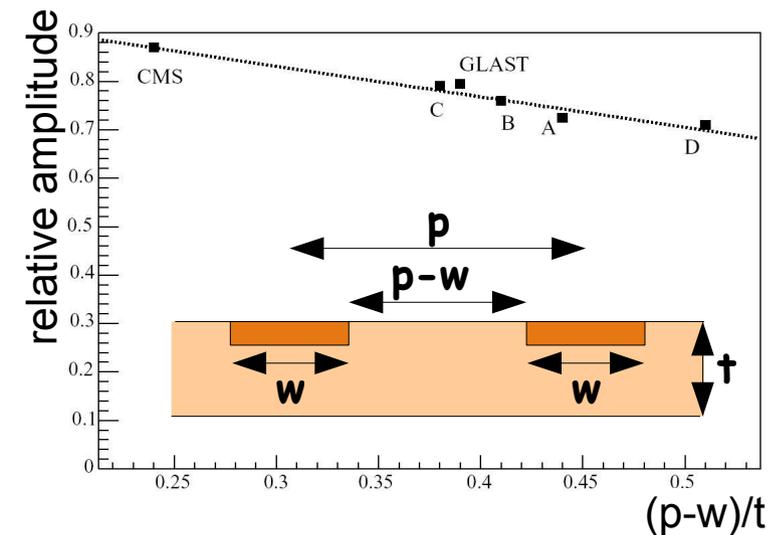
Significant loss of CCE in between readout strips:

- observed on all tested detectors
- not an artefact from clustering
- size of charge loss is independent of strip length, overbiasing, shaping time
- but seems to depend roughly linearly on the ratio (pitch-width) / thickness
- attributed to charge trapping at silicon bulk - oxide interface in between the strip implants
- unfortunately never found the time to do a proper simulation ...

sensor thicknesses chosen such that
 $S/N > 12$ in between strips

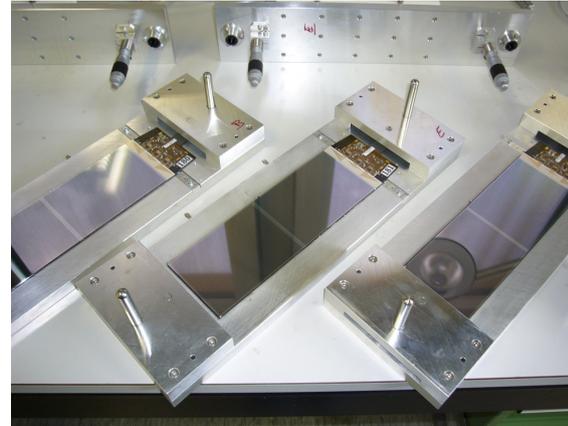
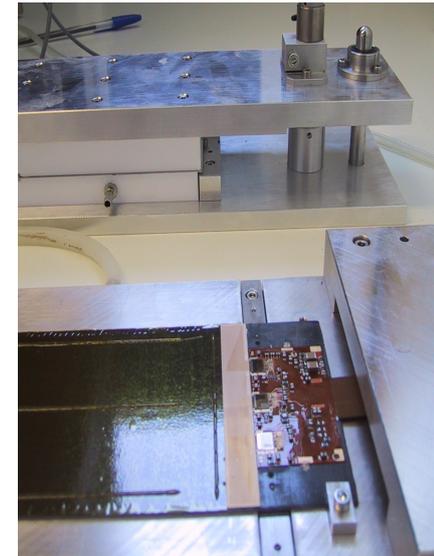
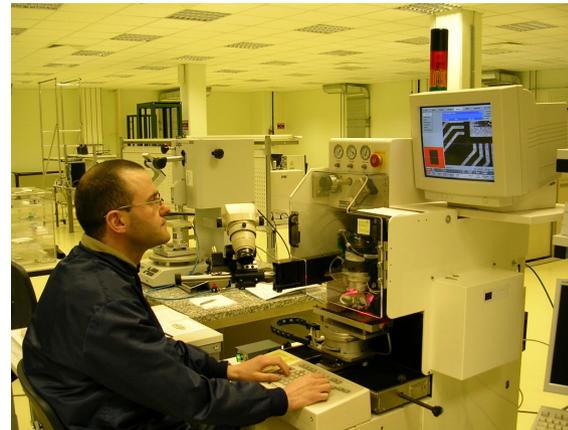
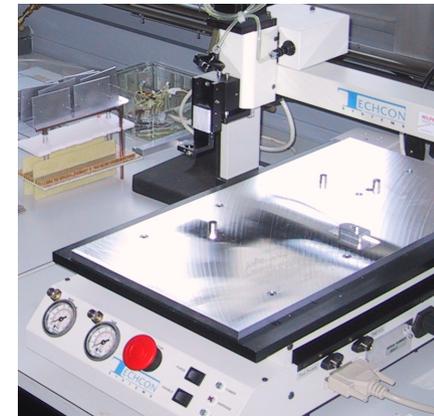
IT Module Production

- position hybrid & pitch adaptor, glue them onto the sandwich support
- **r/o functionality test**
- position and glue silicon sensor(s)
- **measure sensor alignment**
- bond hybrid and pitch adaptor, bond bias and GND to the sensor(s)
- **r/o functionality and HV test**
- bond all readout strips
- **48h burn-in test:**
 - 34 temperature cycles between $+40^{\circ}\text{C}$ and -5°C
 - detectors continuously biased at 500 V
 - readout tests at different temperatures

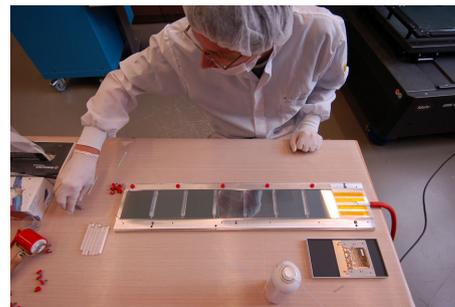
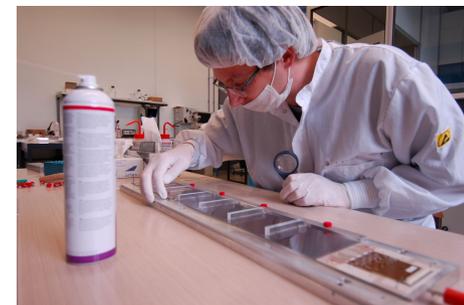
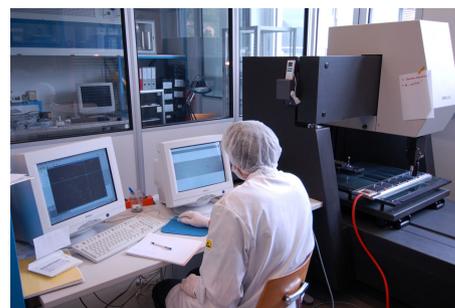
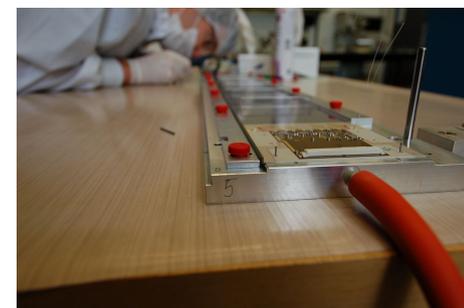
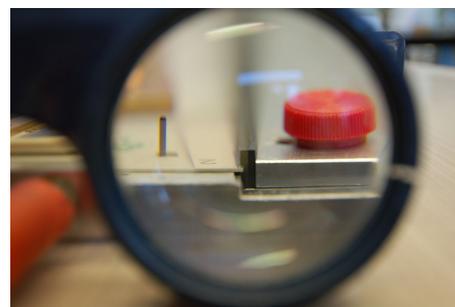
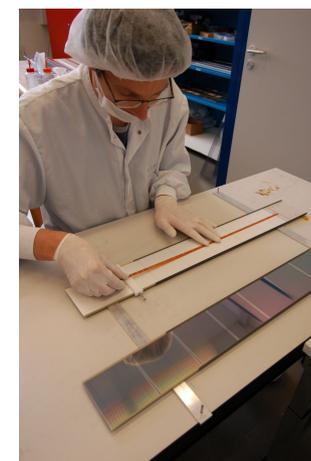
Trigger Tracker Production

- place seven sensors and lower hybrid (use sensor edges for positioning)
- measure and correct alignment (CMM)
- glue support rails along the edges
- measure final sensor alignment
- glue bias voltage cable along back of module, connect GND and bias voltage (soldering / bonding)
- bond sensors and pitch adaptor
- 36 h burn-in test:
 - several temperature cycles between 25°C and 5°C
 - detectors biased at 500 V, currents monitored
 - IV curves and readout tests at different temperatures

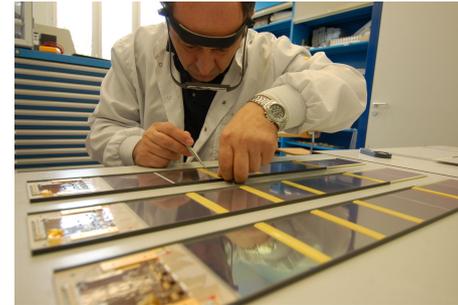
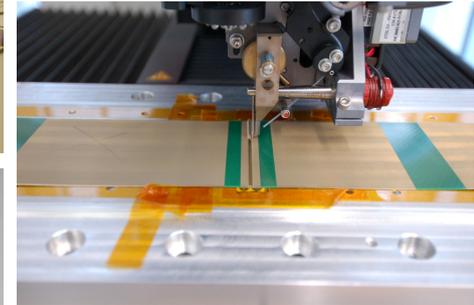
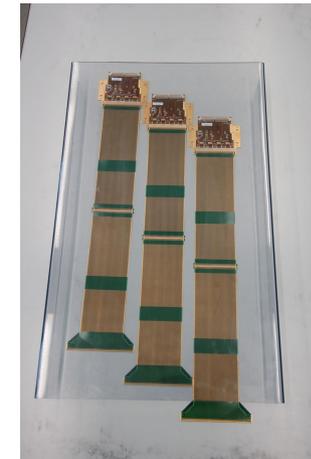
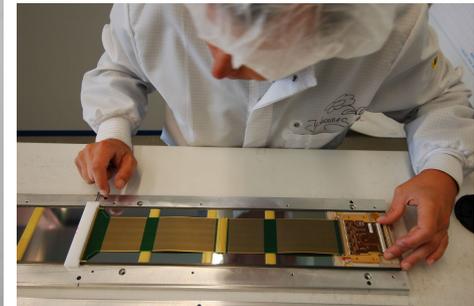
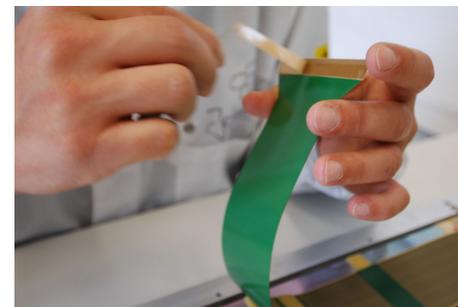
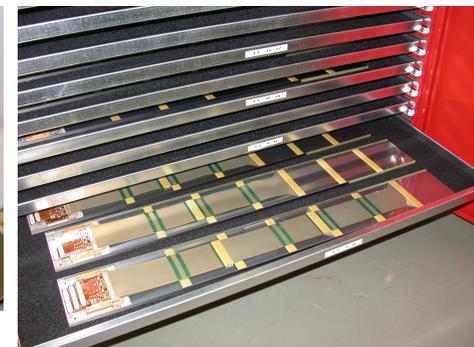
Trigger Tracker Production

- glue Kevlar protection caps over bonds
- assemble, bond and mount Kapton interconnect cable and upper hybrid onto the detector module
- solder GND connections to lower hybrid
- **36h burn-in test**

- for "4-2-1" modules repeat stage-II steps for the 3rd readout sector
- **36h burn-in test**

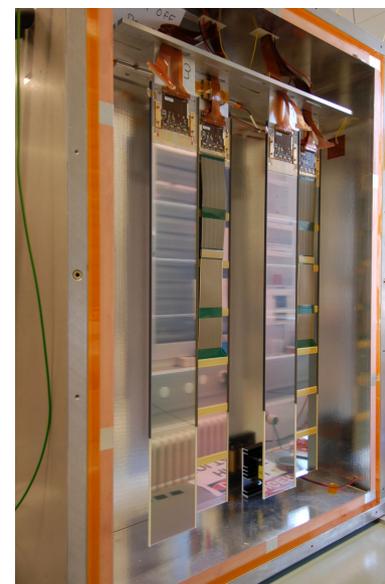
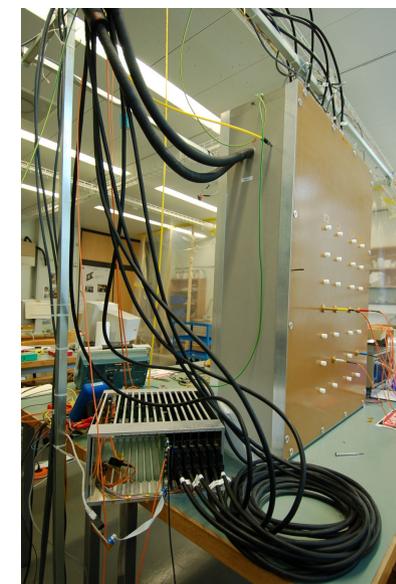
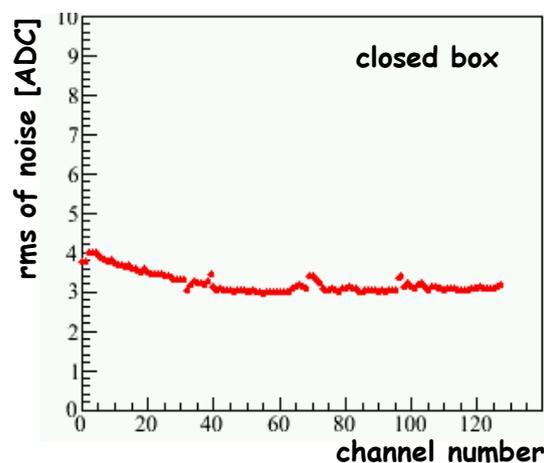
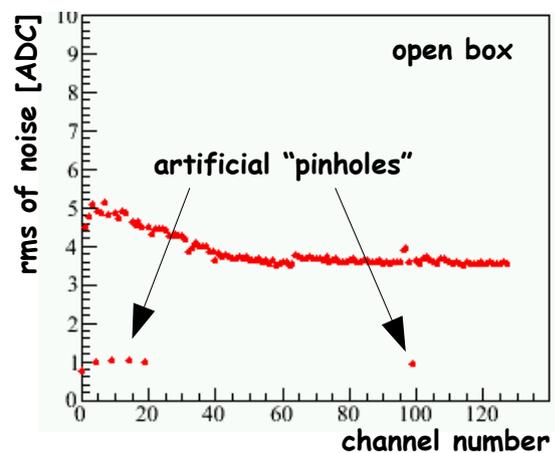
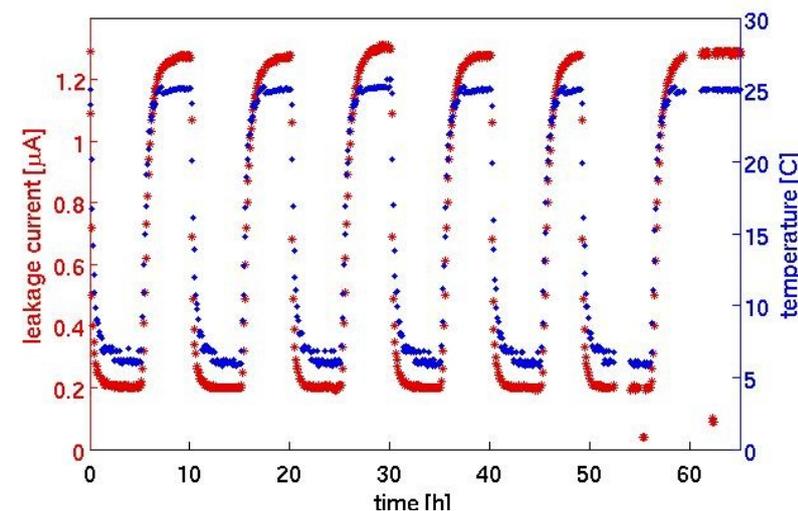
Burn-In Tests

Thermal cycling with readout tests at different temperatures

- pedestal and noise measurements
- pulse-shape and charge-collection scans
 - IR laser to inject signals in sensors (TT)
 - internal test pulse on Beetle chip (TT and IT)
- identify bad strips (open, short, pinhole) from analysis of noise and test-pulse data

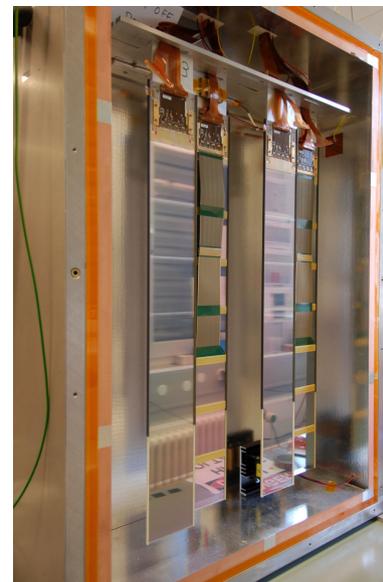
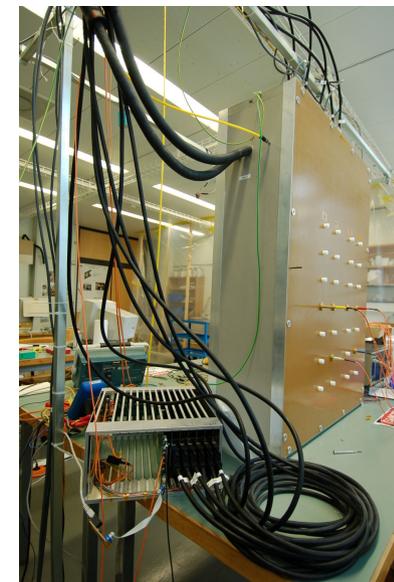
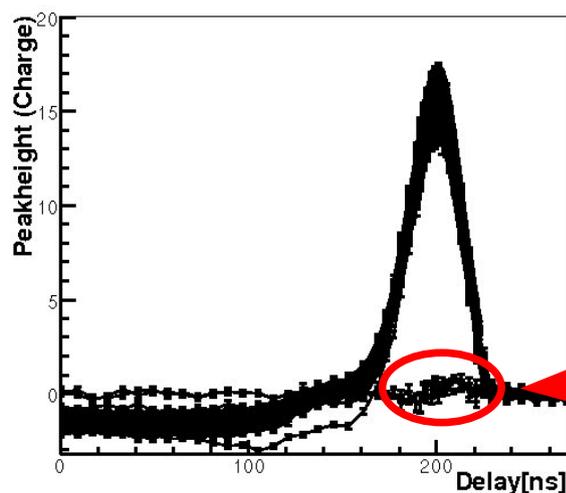
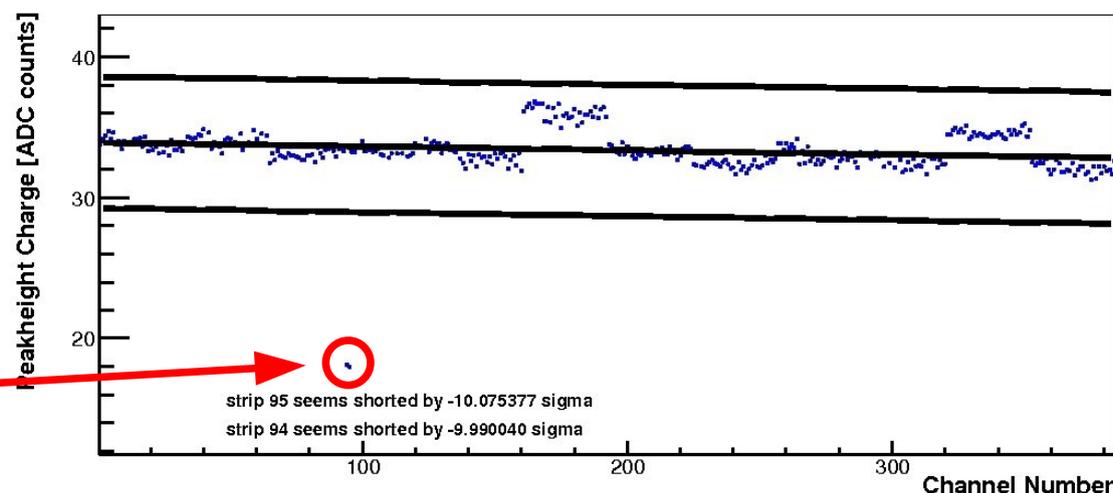
Burn-In Tests

Thermal cycling with readout tests at different temperatures

- pedestal and noise measurements
- pulse-shape and charge-collection scans
 - IR laser to inject signals in sensors (TT)
 - internal test pulse on Beetle chip (TT and IT)
- identify bad strips (open, short, pinhole) from analysis of noise and test-pulse data

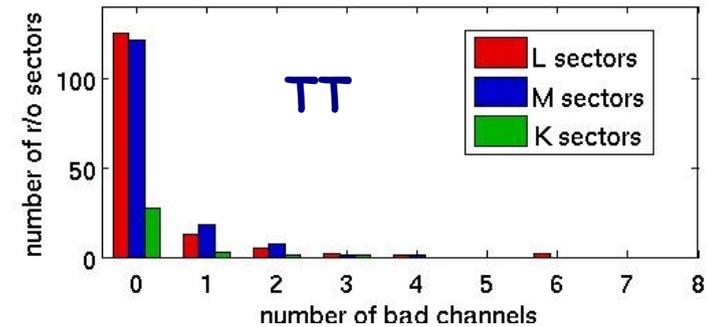
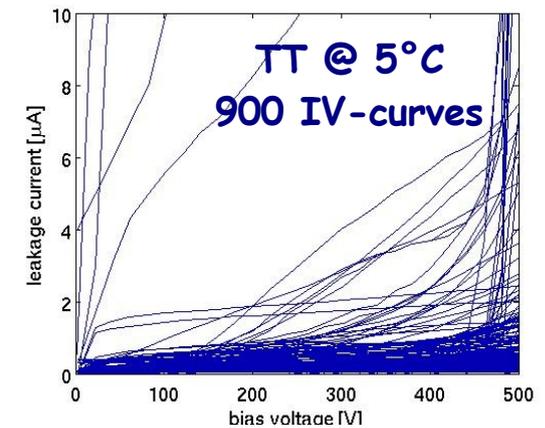
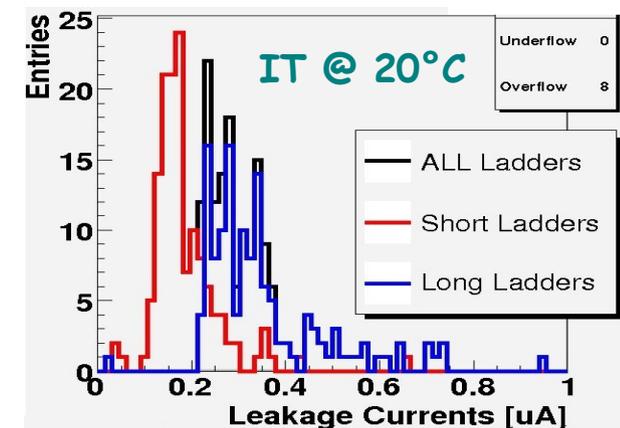
Module Quality

- 147 modules produced (= 15% spares)
- three modules “lost” during production
- three modules had to go through “major” repair cycle (e.g. replace sensor)
- found 109 bad strips out of ~ 158 k tested
- leakage currents typically < 500 nA per sensor

- currently ~ 300 modules produced and fully tested
- some 15 of these show unstable HV behaviour between 350 V and 500 V, under investigation
- fraction of bad strips $\ll 1\%$
- leakage currents typically < 400 nA per sensor

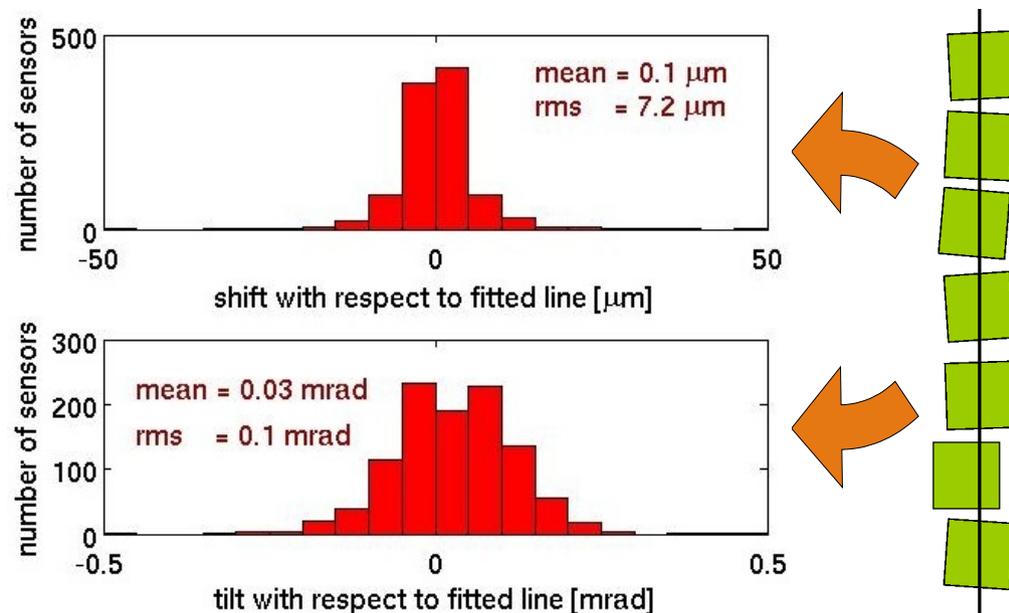
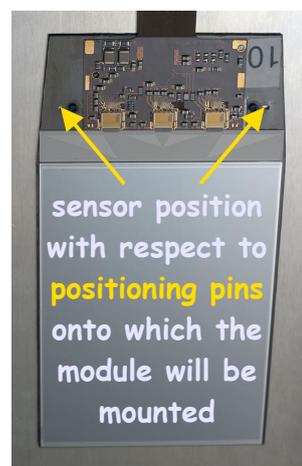
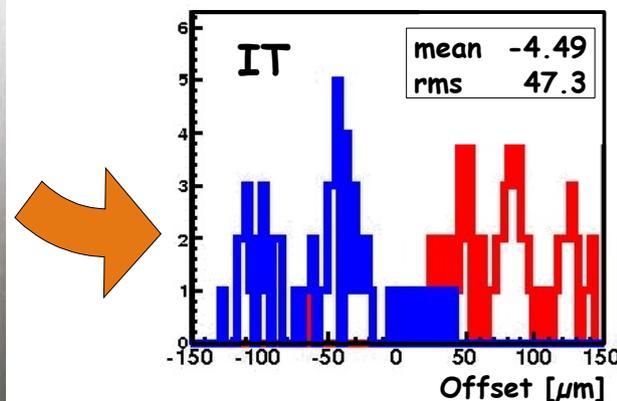
Module Quality

Positioning precision (benchmark: expected spatial resolution of $\sim 50 \mu\text{m}$)

- excellent relative positioning of the sensors on a module
- each module can be treated as one unit in software alignment, no need to align individual sensors
- positioning of sensors on supports worse than what we had hoped for (for IT, not measured for TT)
- mainly due to worse than expected tolerances on production templates
- no problem: software alignment of individual modules was always foreseen

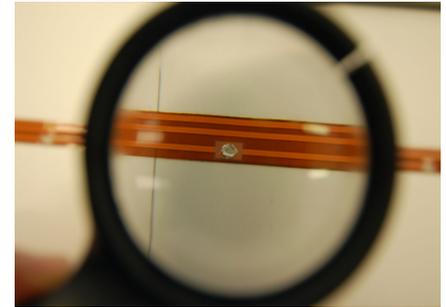
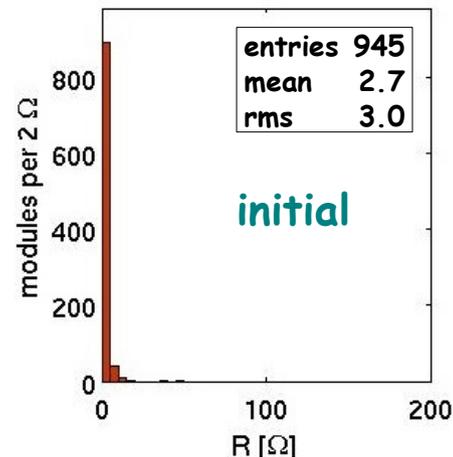
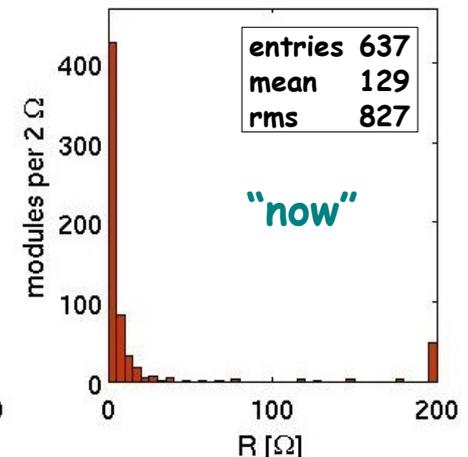
Silver Glue

Silver glue on aluminium is a bad idea (similar effects reported by CMS)

- TT: use Kapton cable to connect bias voltage to sensor backplane
- electrical connection initially done with silver glue
 - TT9-75: Elecolit 340 (one-component "silver paint")
 - TT76-155: Elecolit 325 (two-component epoxy)
- measured resistance of all connections
 - shortly after module production
 - again after a few weeks / months
- find significant increase of resistance
 - for both types of silver glue
 - typically a few hundred Ohms now
- added bond connections on all sensors to avoid long-term problems
- also: some GND connections on IT done with silver glue -> add bond wires

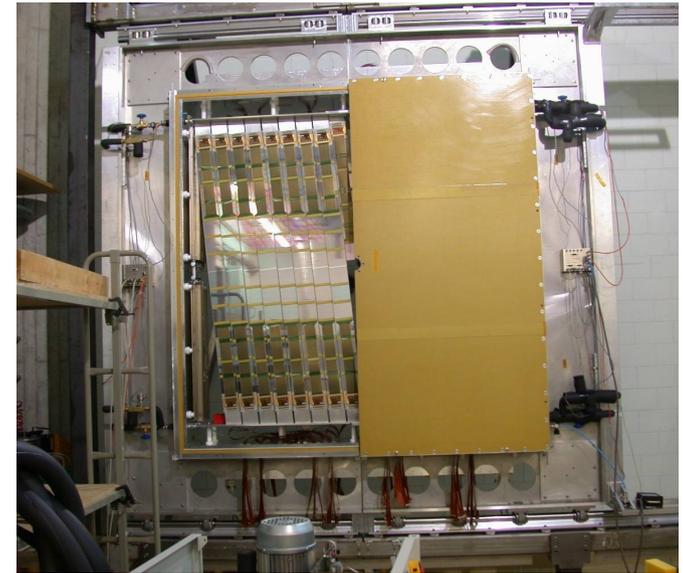
TT (one large detector box):

- test assembly of detector box in the lab
 - included one half-layer of modules
 - extensive mechanical and thermal tests
- detector box now installed in the experiment
- modules will be installed layer by layer
 - HV / readout tests in between any two layers
 - first modules foreseen for March

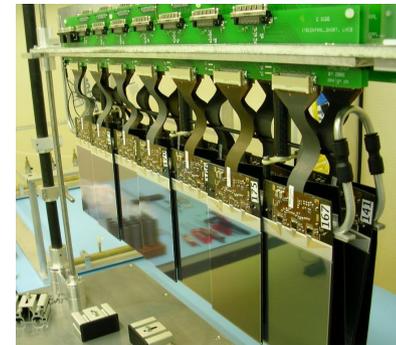
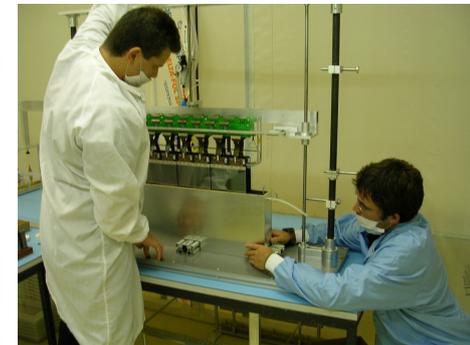
IT (12 individual detector boxes):

- first box assembled and being debugged
- commissioning of each box in the lab
 - installation of first box foreseen for March
